RE: Technical Field Visit, Deer Creek Waste Rock Storage Facility, PacifiCorp, Deer Creek Mine, C/015/0018

Clarify the location and condition of sediment control measures at this locale, in particular the undisturbed drainage bypass ditch on the north side of the facility.

TECHNICAL FIELD VISIT

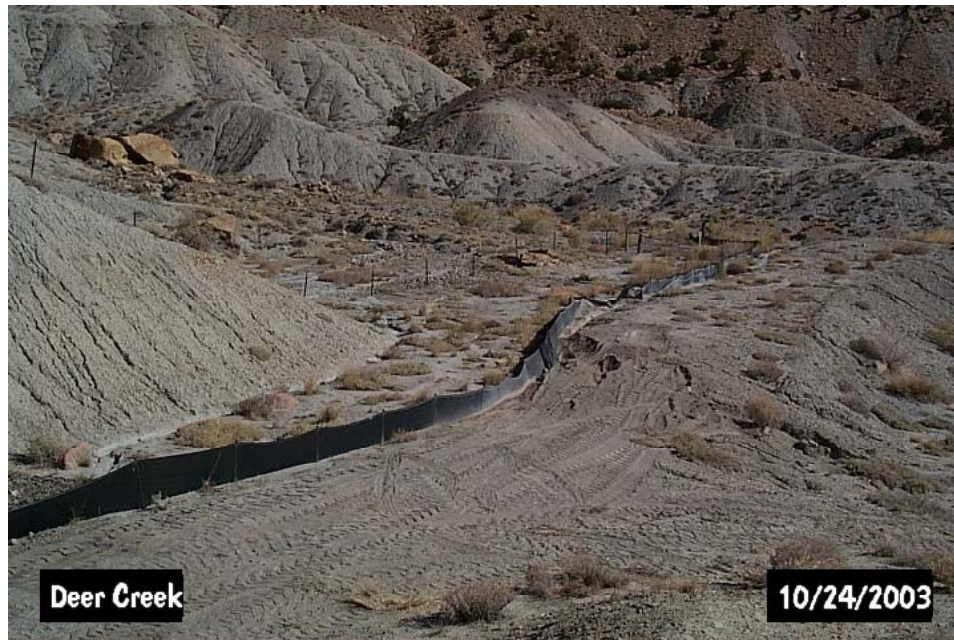
- e. The ditch will be cleaned to comply with the MRP.
2. There is a berm made of topsoil on the north, west, and south sides of the waste pile.
- a. The outslope of the topsoil berm is an ASCA (see Plate 4-5 and photo P0002129).

- i. The plan isn't clear, but apparently silt fence located between the berm and ditch is the sediment control measure for this ASCA.
    - ii. Without a functioning undisturbed drainage bypass ditch, the silt fence has been keeping sediment from the undisturbed areas out of the waste rock site rather than retaining sediment on the site.

- 1. At several locations, the silt fence has been knocked-down or torn by water and sediment coming from the undisturbed side: this resulted in NOV #NO3-49-4-1.

P0002129 Looking northeast along the berm, where the silt fence has been overwhelmed by sediment from outside the disturbed area. The undisturbed bypass ditch is completely filled with sediment.

- 2. The silt fence will be repaired to abate the NOV.
  - b. Even with the undisturbed bypass ditch full of sediment and the silt fence in disrepair; the topsoil berm isolates the coal mine waste from the undisturbed water and sediment.

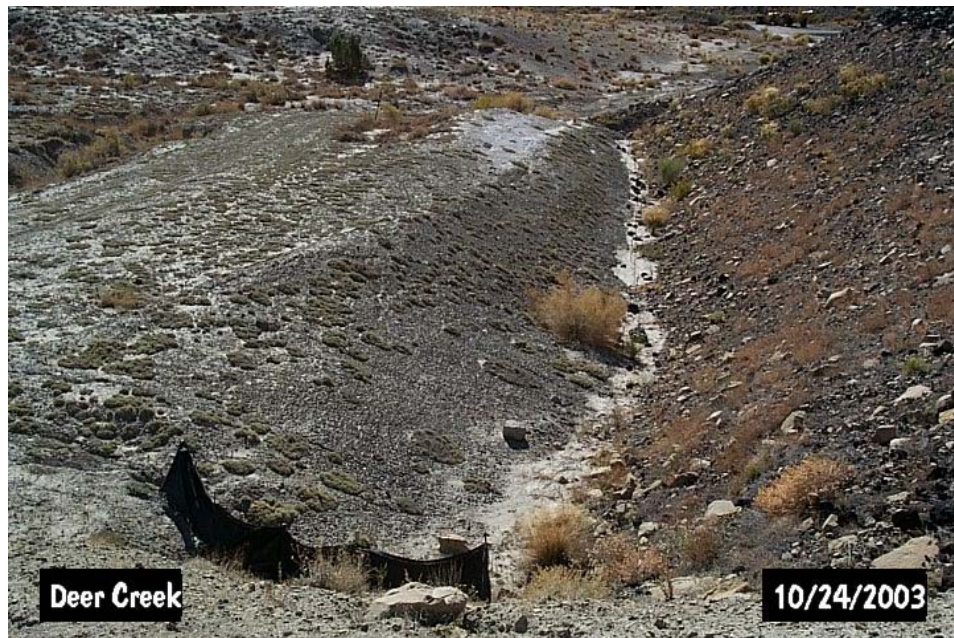
1. The undisturbed drainage bypass ditch, on the north and west sides of the Phase I waste rock pile (see MRP Plate 4-5), is completely filled with sediment from years of runoff from the undisturbed drainages north of the site (photo P0002131).
  - a. The ditch was built when the site was constructed, around 1989.

- b. The ditch was cleaned around 1991 (Dennis Oakley – personal communication, based on his conversations with other PacifiCorp personnel).
  - c. When Dennis started work with PacifiCorp in 1997, the ditch was buried in sediment to the point it was no longer evident there was a ditch.

- d. Permit-boundary fencing from the original construction is half-buried in sediment where it crosses the drainages, and newer fencing has been installed on top of the sediment.

P0002131 "Ditch" between the disturbed area and the BTCA area on the east end of waste pile.

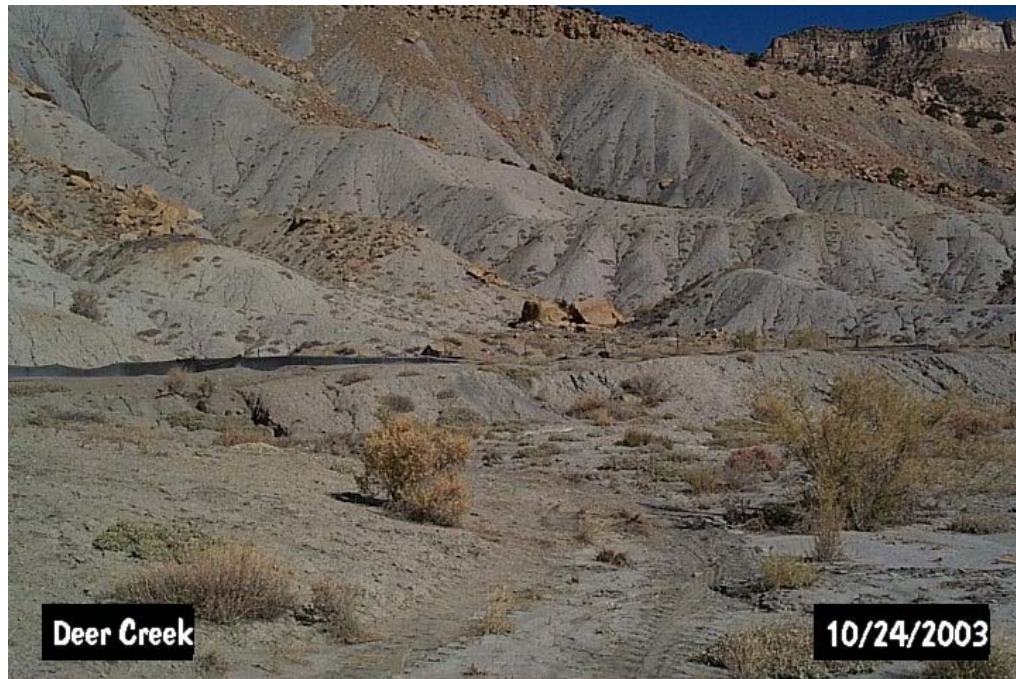
- ii. In this section extending to the east, the berm has been topped by undisturbed runoff, the top of the berm has been eroded and sections of silt fence flattened (photo P0002133.)

- iii. After crossing the berm, undisturbed runoff flows across the disturbed area east of the waste pile and to the existing drainage channel on the south side.

3. Most of the waste rock pile drains to a sedimentation pond, but the east side of the waste rock pile is designated as a BTCA area (see Plate 4-5 and photo P0002133.)

P0002133 Undisturbed flow overruns the silt fence and erodes the topsoil berm east of the waste pile.

- iv. Cleaning the undisturbed bypass ditch should eliminate the problem of undisturbed drainage flowing across this berm and the adjacent disturbed area.

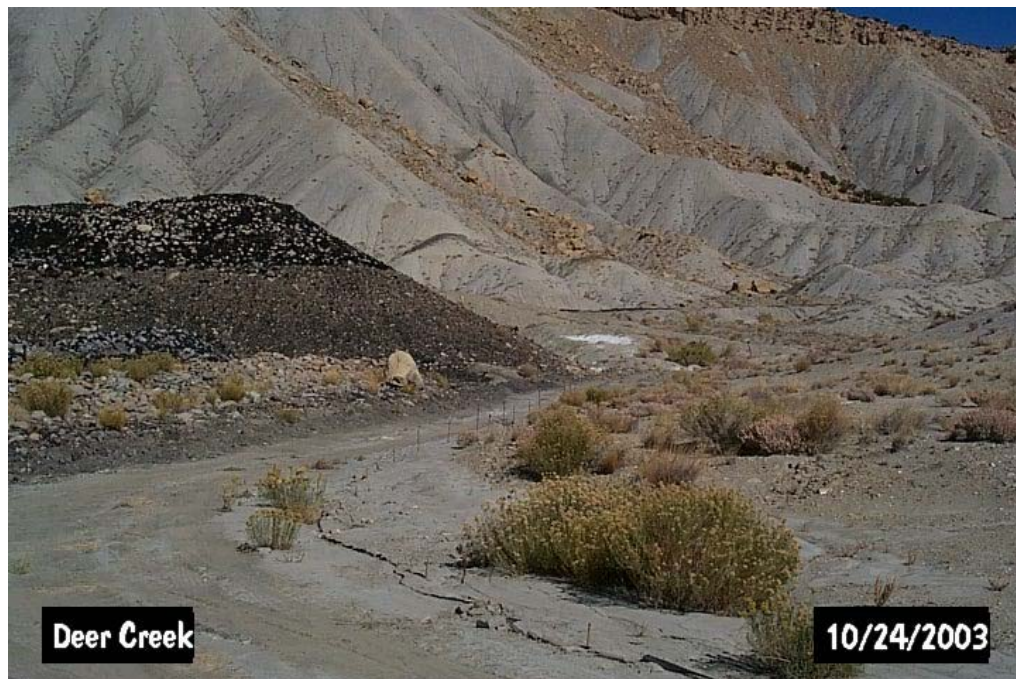
- c. On the north side, the berm, silt fence, and presumably the ditch extend east beyond the waste rock pile.
    - i. This section of the berm is considerably lower than that adjacent to the waste rock (photo P0002135.)

- i. This ditch directs drainage from the BTCA area to the existing drainage channel on the south side of the site.
    - ii. Silt fencing in this ditch has been removed, although the roof-bolt supports are still in place.

P0002135 East toe of the waste pile. Roof bolts and silt fence cut flush to the surface indicate where the silt fence was located. Berm in the background crosses an undisturbed drainage (see P0002133.)

The Permittee is repairing the silt fence and cleaning the undisturbed drainage bypass ditch on the north and west side of the waste pile and restoring the sediment control measures for the BTCA area on the east end of the waste pile.
